**Alcatraz Quartermaster Building Seismic Upgrade  
ICRI Northern California Chapter  
2017 Concrete Repair Awards Submission**

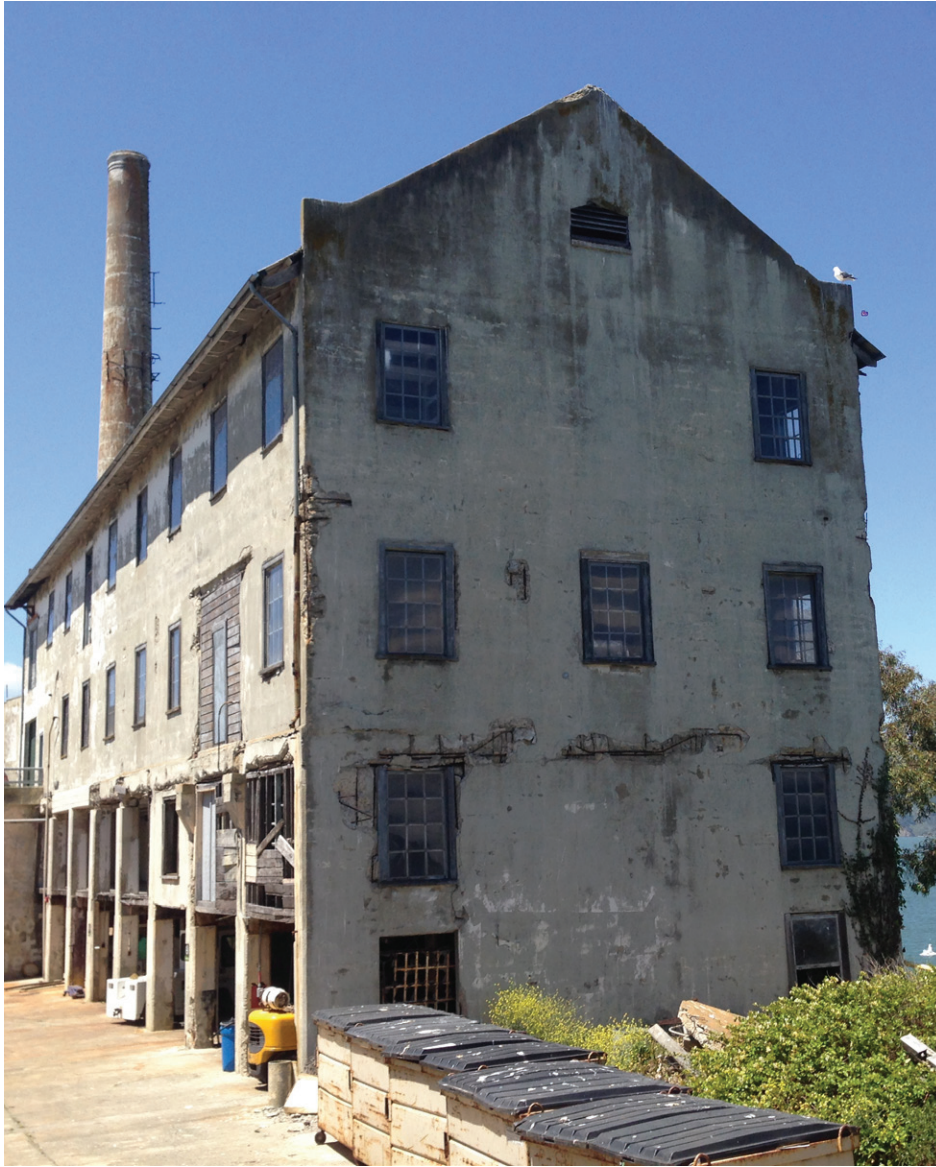
*Quartermaster Building before Restoration, c.2013*

including large spalls and exposed corroded reinforcing steel at the walls, beams, columns, and floor slabs. Deterioration was most severe at the exterior walls, but also visible throughout the interior. In many cases, rebar was observed very close to the surface at cracks and spalls.

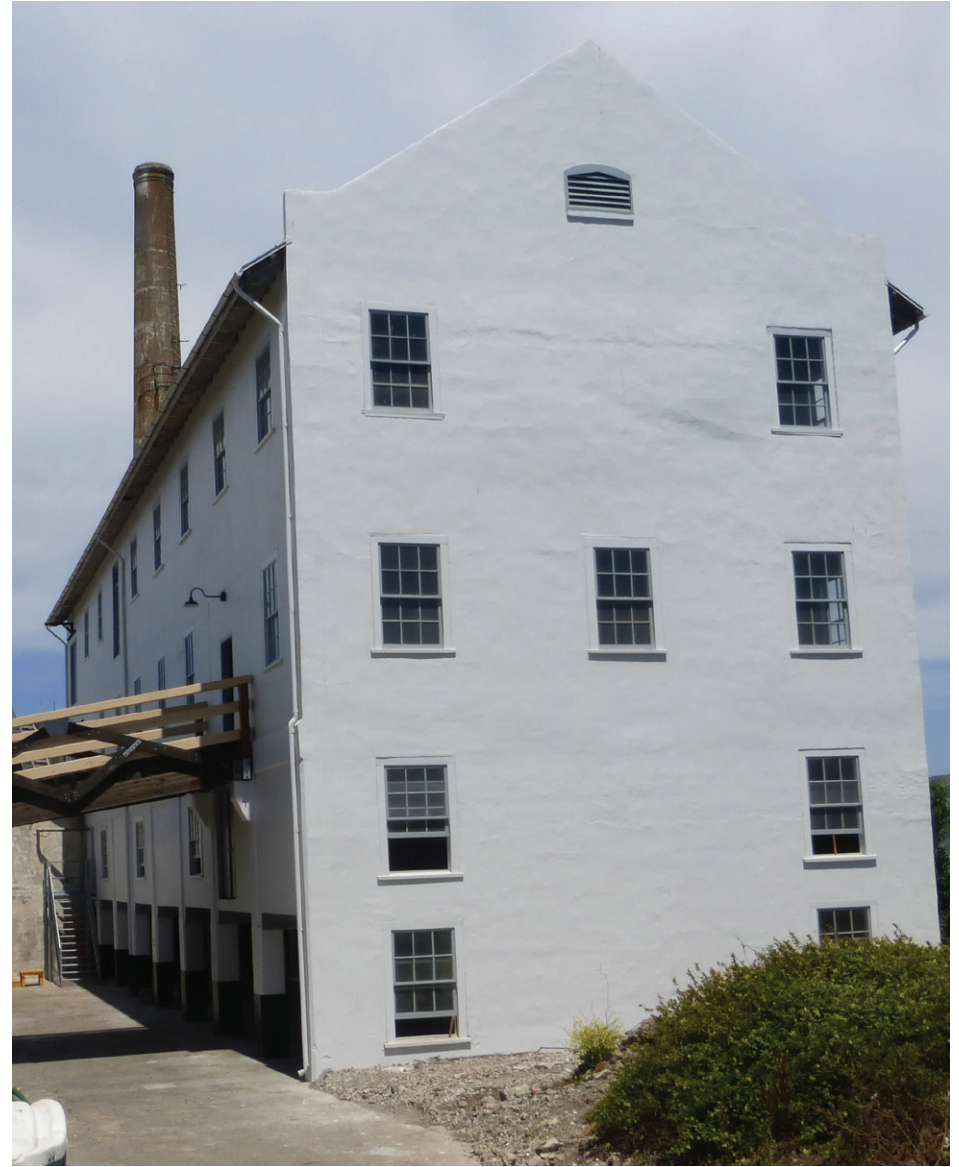
*Quartermaster Building after Restoration, 2016*

A Sika repair system, including a large-repair concrete mix product, small-scale repair mortar, repair mortar for the parge coat, bonding agents, and a series of protective finish coatings, was used to create a comprehensive repair assembly.

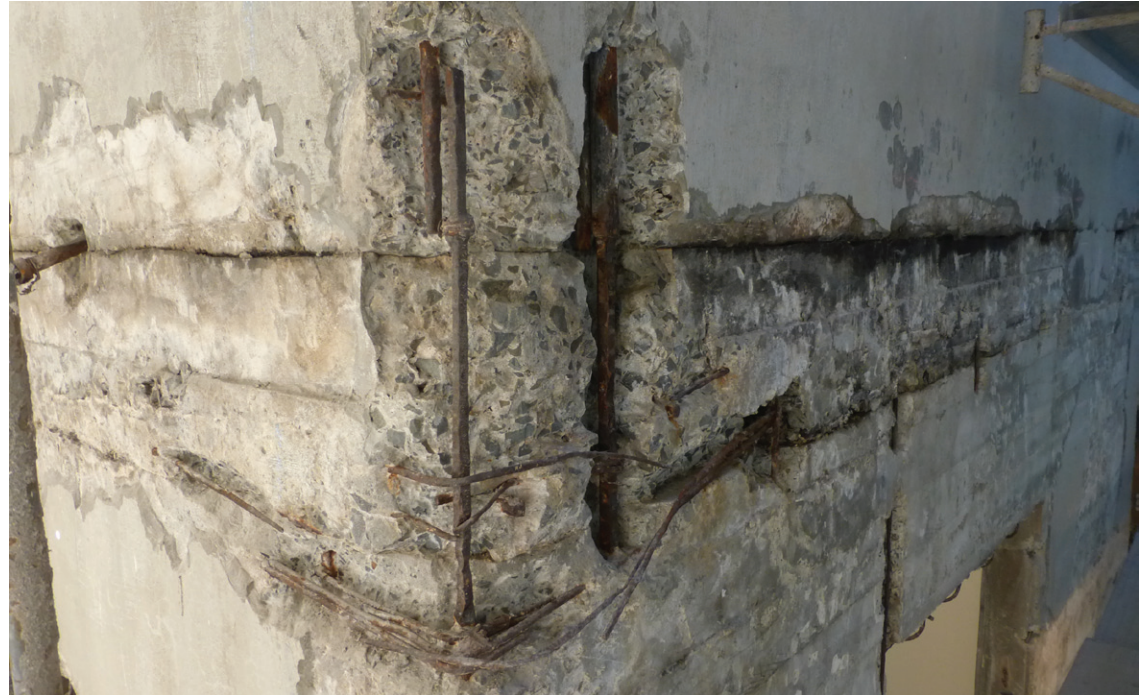
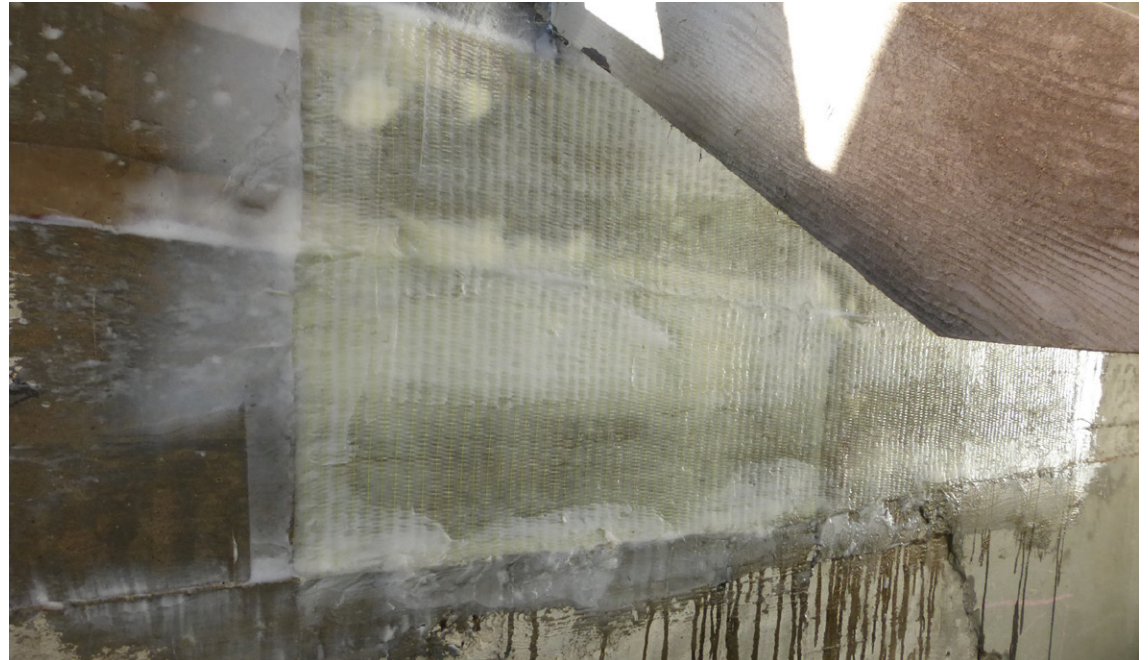
It is assumed that the Quartermaster Warehouse was constructed using Army prison labor, and the building's original craftsmanship was accordingly low in quality. During demolition of the damaged concrete and parge coat, it was discovered that the four building stories had been poured in separate lifts and were not structurally connected to each other. The discovery of these cold joints required the modification of repair details, including the addition of FRP reinforcement at each horizontal joint. The FRP was ultimately concealed behind the new parge coat, allow for repair without any visual change to the historic façade.

Quartermaster Building conditions during construction including (top) the cold joint revealed during parge coat demolition, which was repaired through the exterior application of FRP (below), which was then concealed behind the new parge coat.

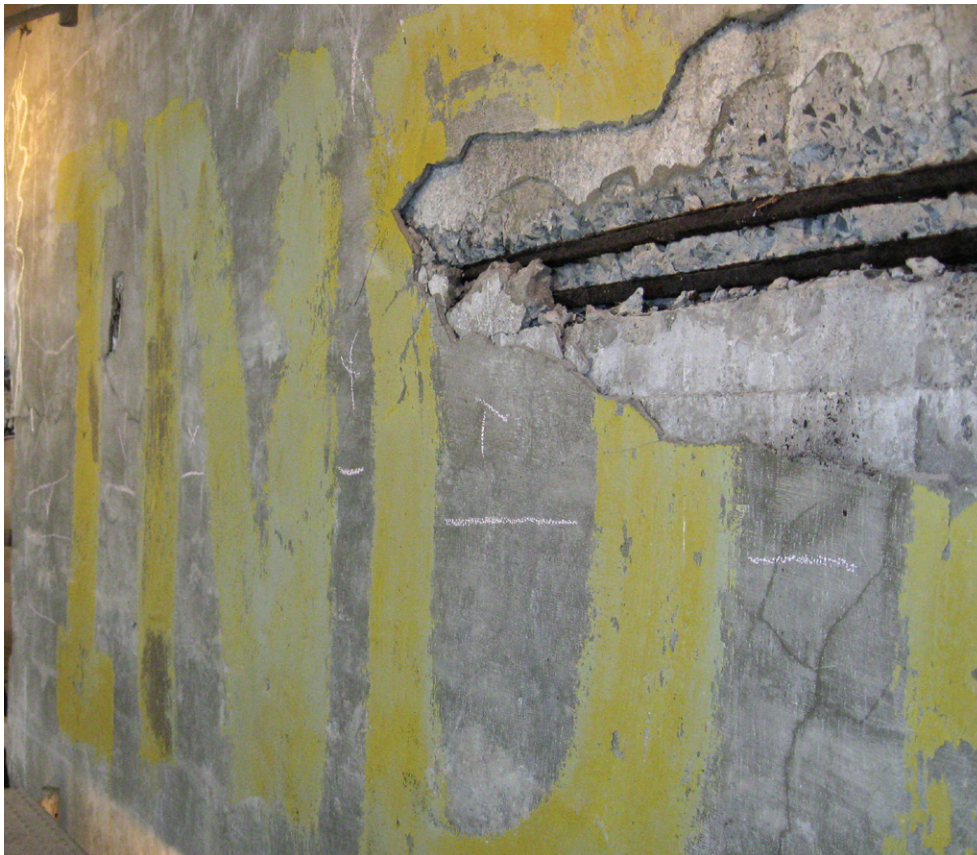
*Typical conditions at locations of Political Statement prior to concrete repairs, 2014.*

The Quartermaster Warehouse has several painted political statements throughout the building. Most significantly, on the east elevation the words “Indian Land” are written in yellow paint. The concrete substrate that the political statement was painted on was deteriorated and needed to be included in the concrete repair project. The NPS maintains an agreement to work with a council of Native Americans when rehabilitations could impact the painted political statements, and they were consulted as part of this repair project.

The decision was unanimous, to restore the painting after repair of the exterior wall surface. The Political Statement was recorded with a full size tracing of the lettering created with the support of a decorative painter. After repair of the wall surface, the tracing was transferred to the wall surface by the Contractor for the rehabilitation project. In March 2016, Native Americans from various tribes gathered to complete the painting. The political statement is now more visible and rests on a stable, repaired concrete substrate.

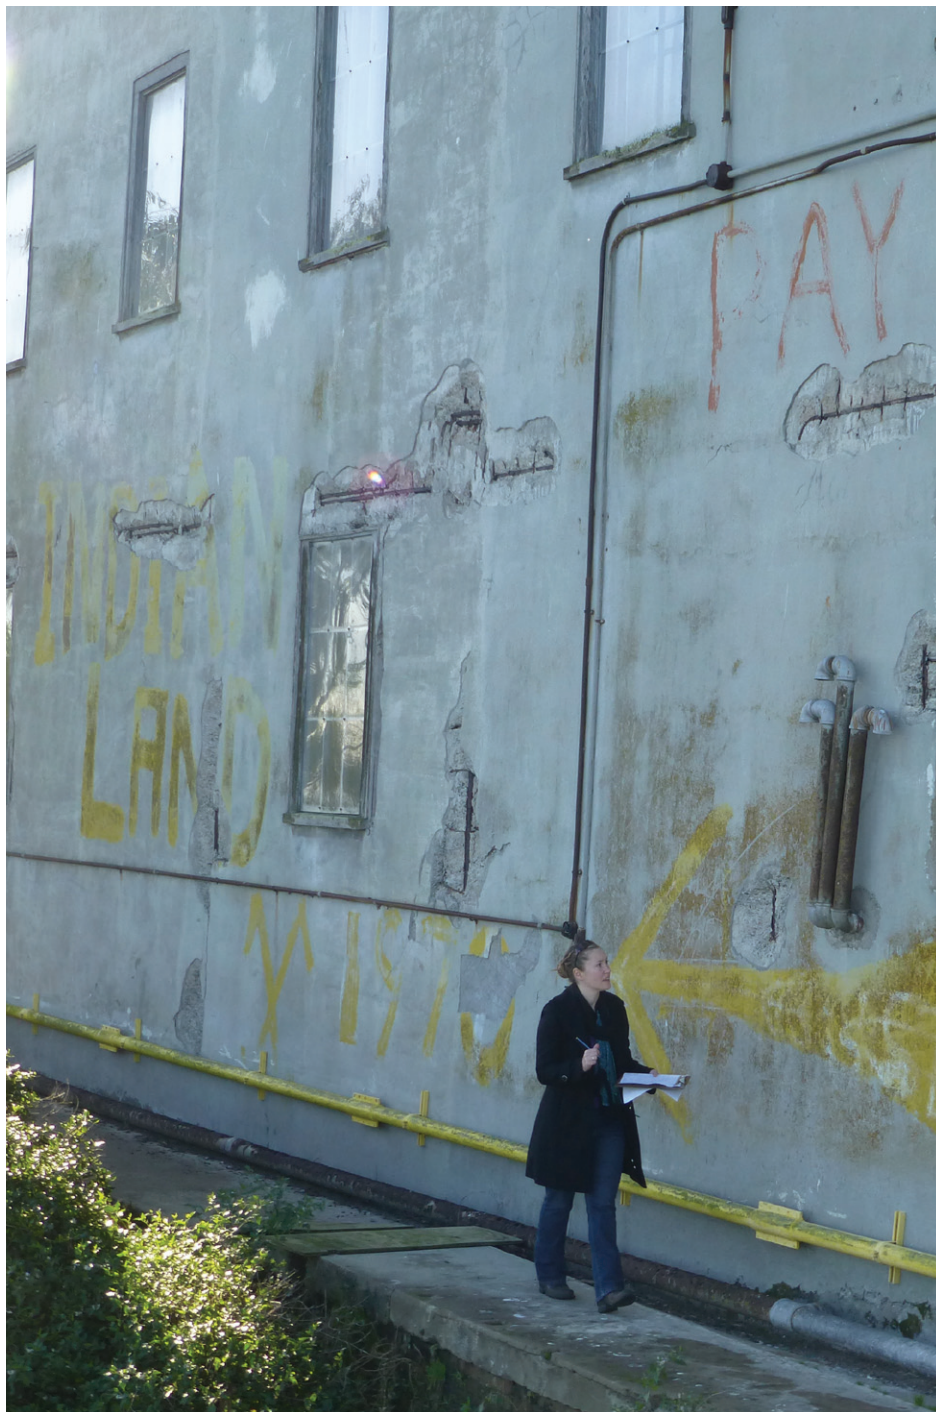
Conditions at east elevation of Quartermaster Warehouse c.2014.

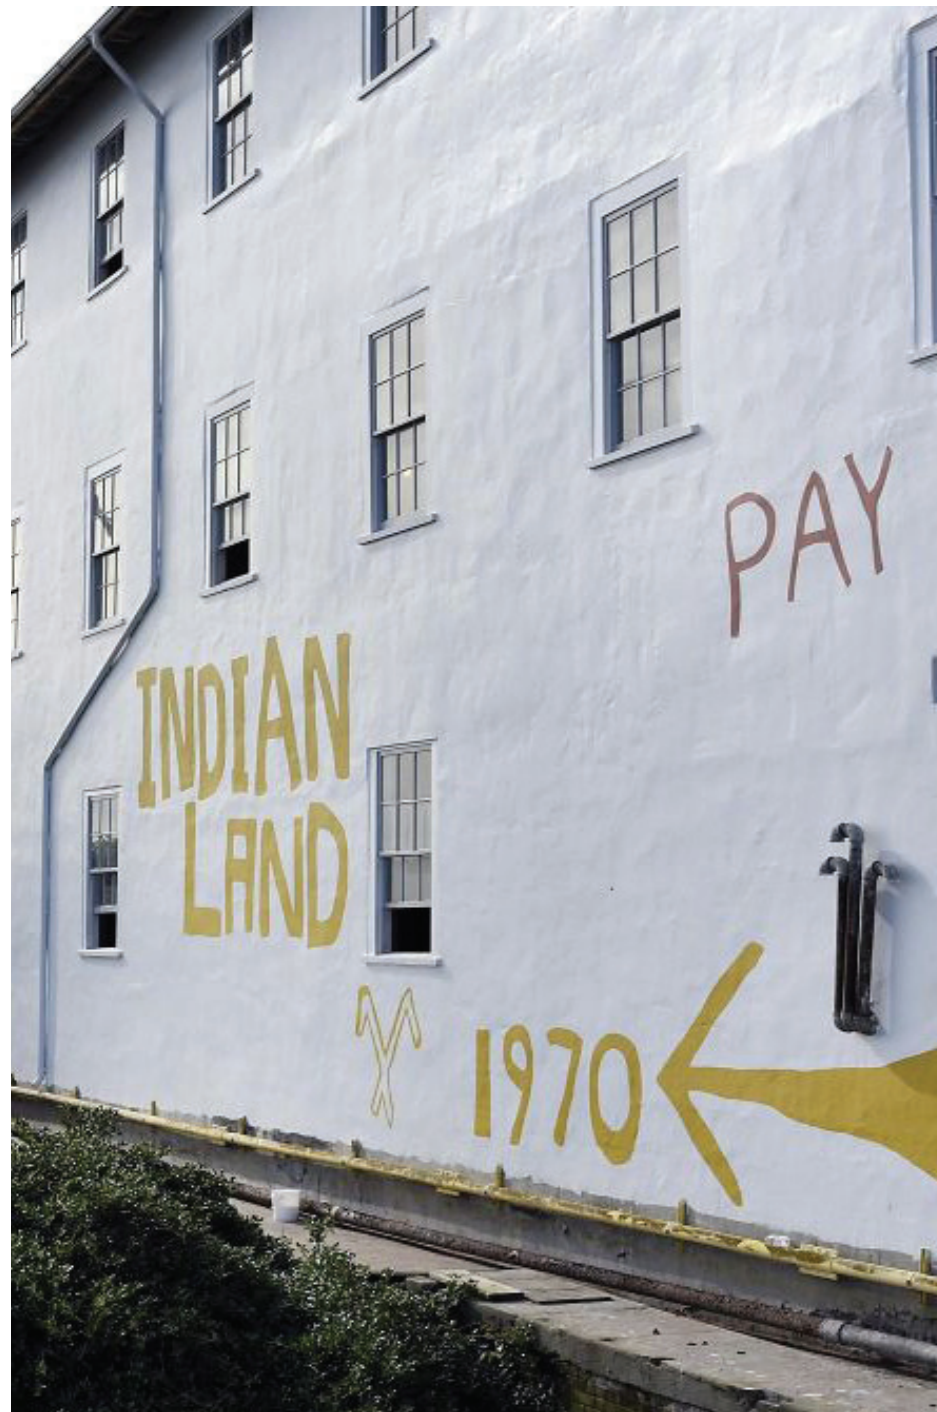
Conditions at east elevation of Quartermaster Warehouse following repair project, 2016.

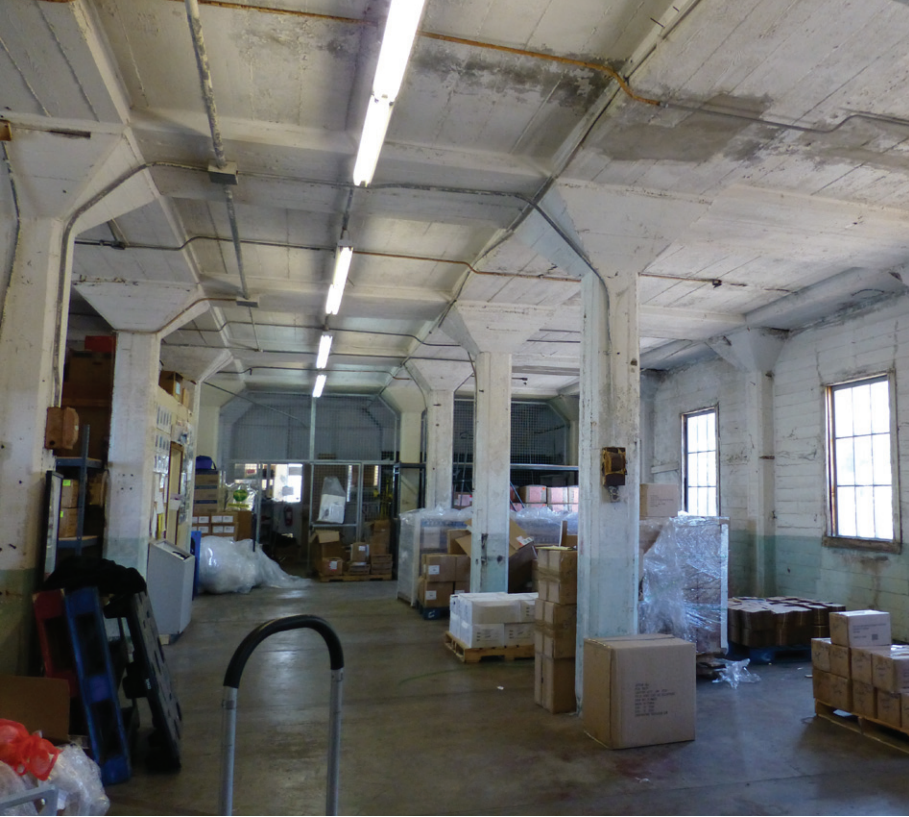
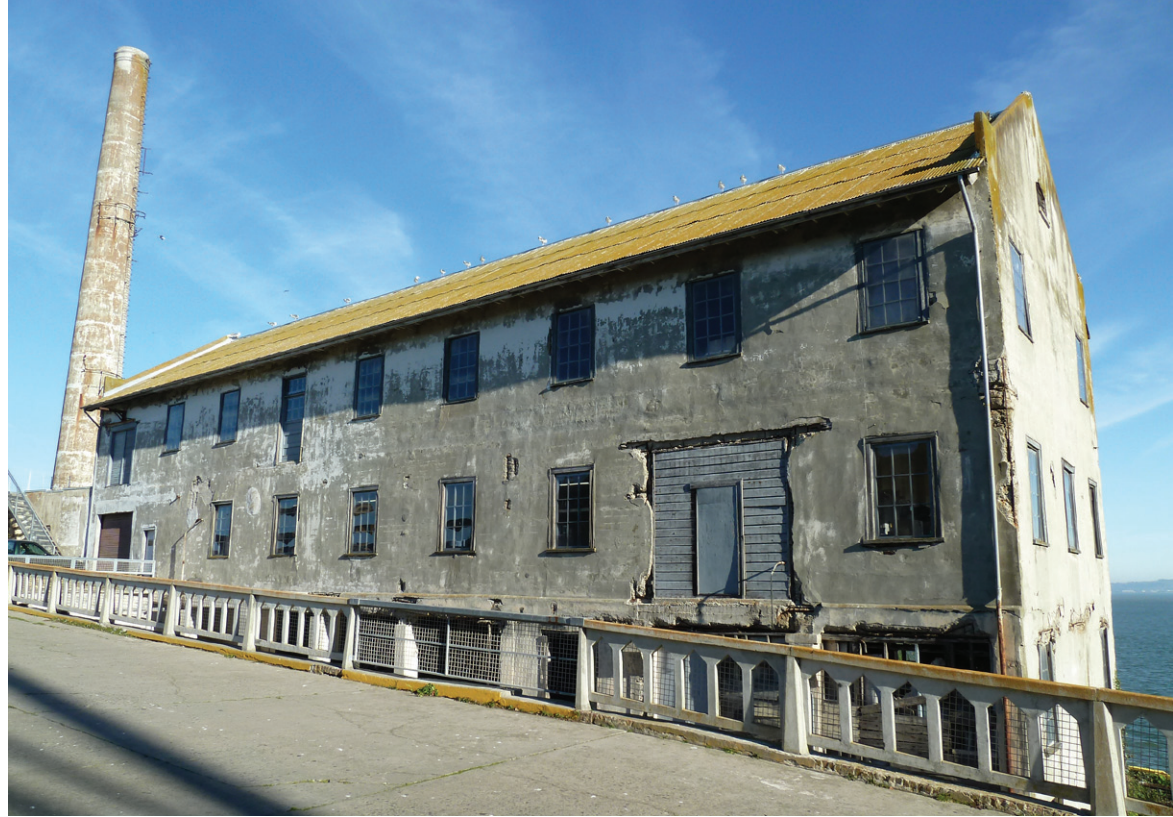
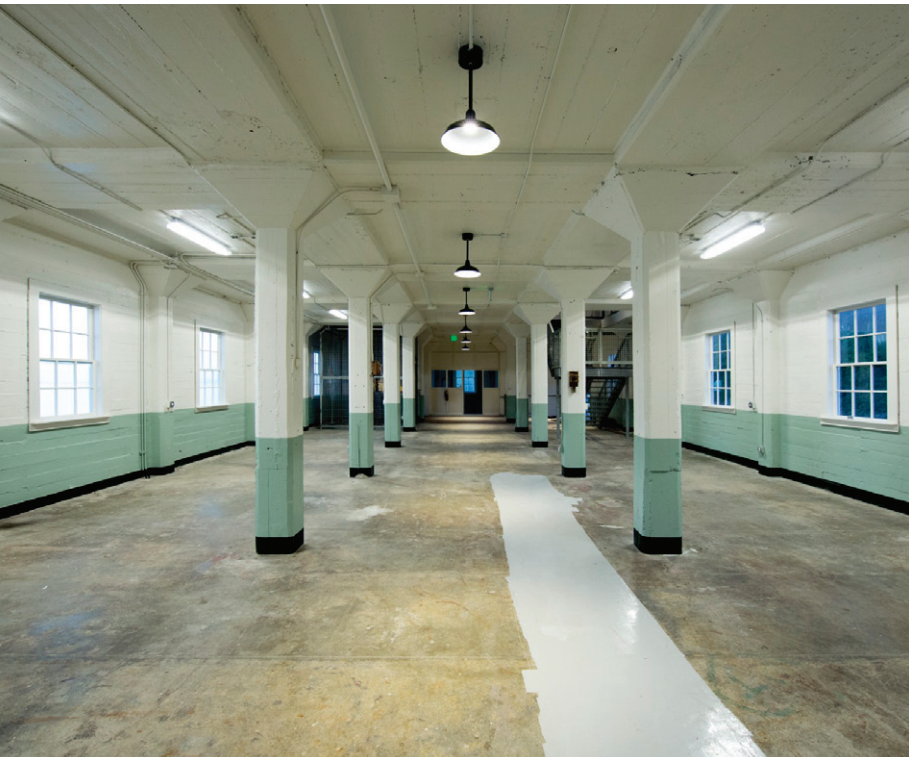
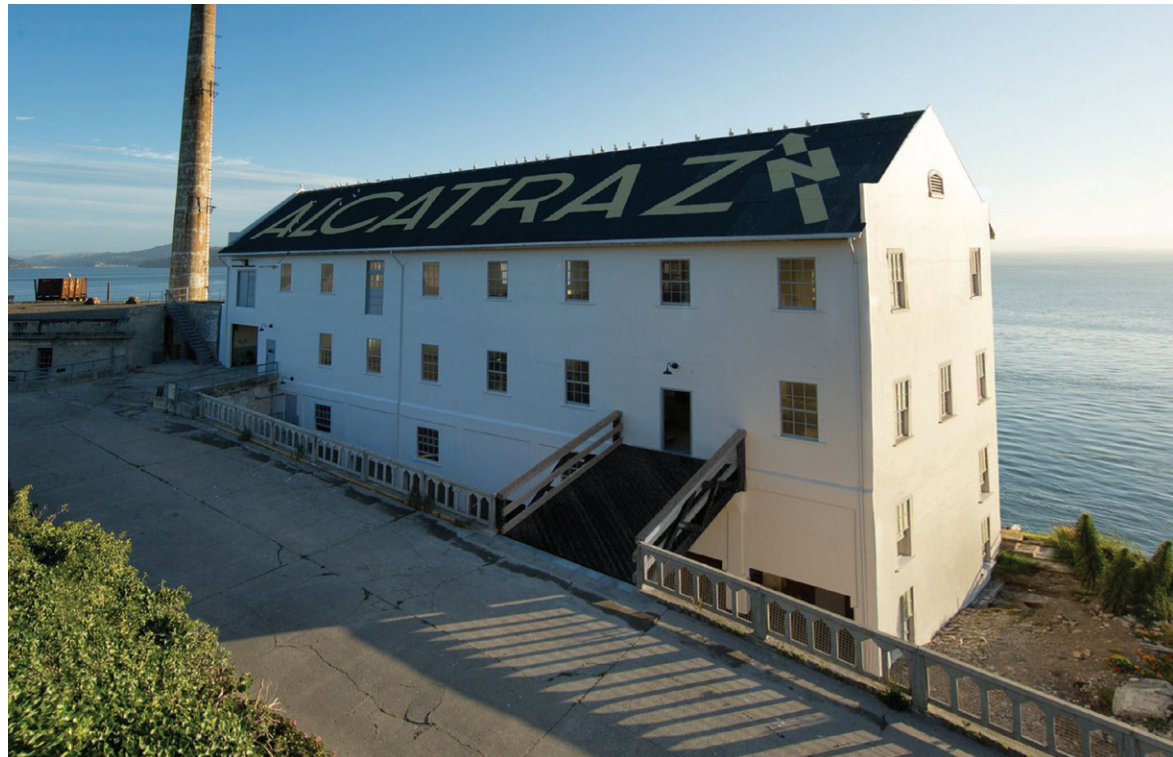
*Interior and exterior conditions before (top) and after repair project. After photos throughout submission are by Michael David Rose, 2016.*
