## Restoration of 100+ Years Old Public Building

Project: Hall of Records, Bakersfield, CA

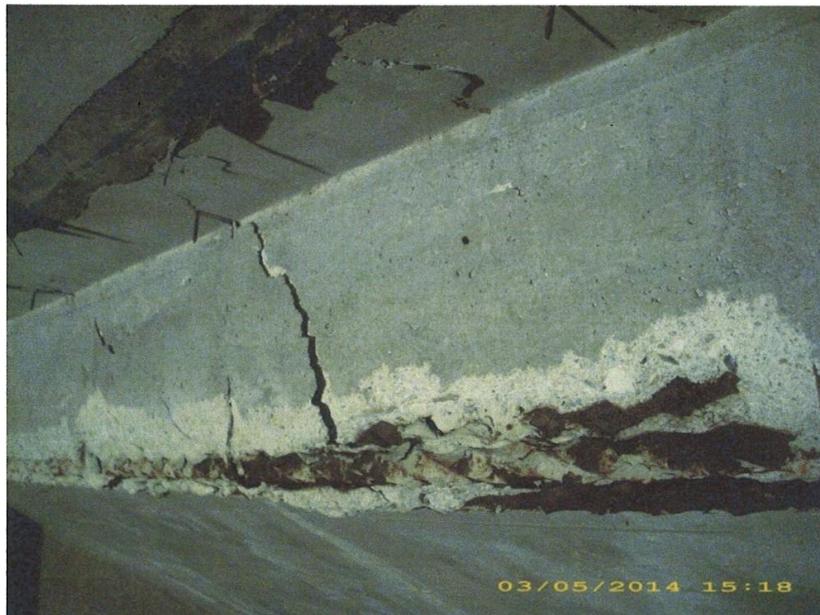
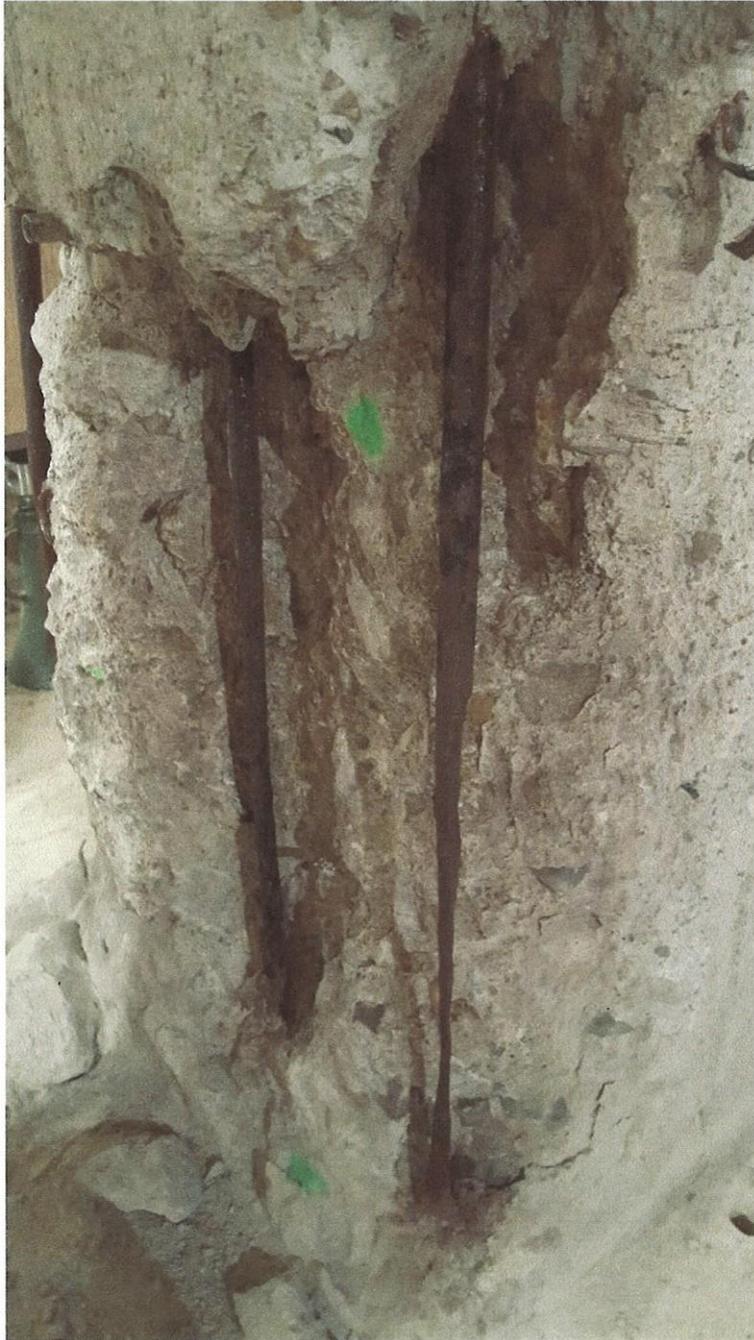
Signs of concrete deterioration in the approximately 9,000 ft<sup>2</sup> unfinished crawl space were noted during the 1988 retrofit, and in 2013 investigations showed that several columns, pilasters, and beams showed signs of severe spalling, delamination, corrosion, and cracking. A more detailed investigation was requested to determine any additional defects in the crawl space concrete and the cause of the reinforcement corrosion.

- The tests showed the concrete strength to be typical for its vintage with no significant internal voids or delamination. The visually active corrosion locations were substantiated by the tests and the cause of the corrosion was deemed to be both inherent in the concrete and further exacerbated by the corrosive soil. The soil samples taken from inside the crawl space indicated an average resistivity of 592 ohm-cm, a pH of 9.06, average chloride content of 679 mg/kg with a maximum of 2,500 mg/kg, and an average water-soluble sulfate content of 1009 mg/kg with a maximum of 6,100 mg/kg. The clearly corrosive soil left its mark on the concrete, with the chloride content of the concrete ranging from 0.07 to 16 lb/cu yd of concrete. The pH of the concrete ranged from 9.5 to 11. The depth of carbonation reached from 1-inch depth in the footings to over 4-inch depth in the columns, beams, and walls.

Over the years, the high chloride and sulfate content in the soil migrated into the concrete. It is also highly possible that the original concrete mix used calcium chloride as an admixture. Given the vintage, the concrete was probably mixed in small batches and contributed to the uneven, high chloride content of select beams and columns above the soil. The extensive carbonation of the concrete, beyond the depth of the concrete cover, has accelerated the corrosion of the reinforcing.
