# PG&E BUILDING AT 215 MARKET STREET

*San Francisco, CA*

ICRI Northern California Chapter  
2017 Concrete Repair Awards  
Simpson Gumpertz & Heger Inc.

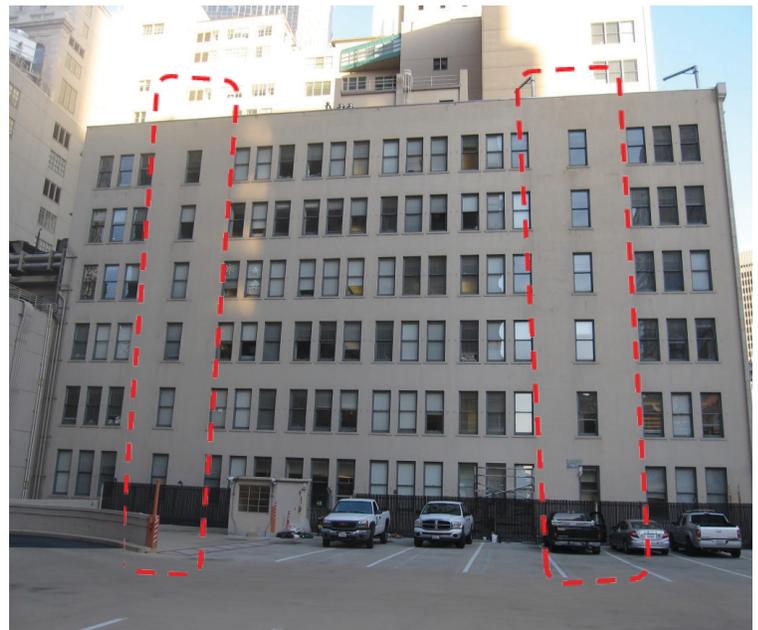
The building's south elevation is cast-in-place concrete covered by a painted plaster parge coat. The façade is punctuated by original double hung wood windows (Photo 1).

**PHOTO 1:** *South Elevation. Outline shows areas where shear walls were previously added.*

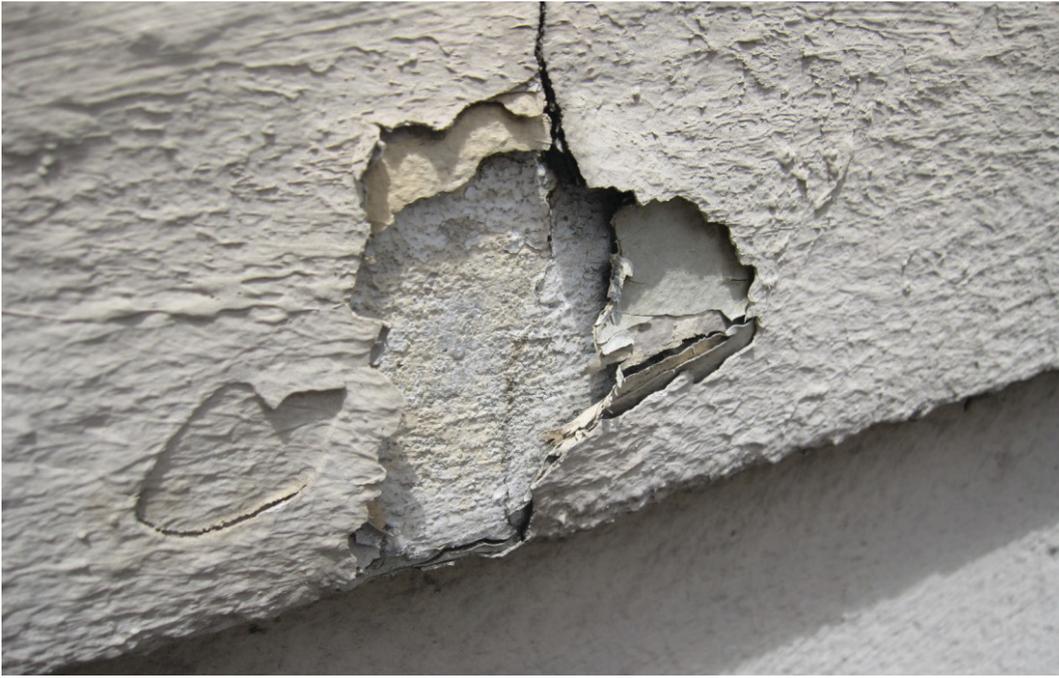
**PHOTO 2:** *Blistered and peeling paint. Concrete is cracked.*

The exterior wall finishes on the south elevation of the 215 Annex Building consisted of plaster-coated concrete. The plaster coating was in turn covered by numerous applications of paint, which was blistered, filled with water, and peeling in various locations (Photo 2). In addition to the failed coatings, we observed localized cracking and spalls in the concrete substrate, corrosion of embedded metal, as well as failing previous patches (Photo 3).

For this type of barrier wall assembly, the exterior paint and plaster layers act as the waterproofing of the concrete and prevent moisture penetration into the building. As such, we recommended repairing cracks and spalls in the concrete and plaster followed by an elastomeric coating system to restore the wall to watertight condition. We also suggested that PG&E repair the wood windows at the same time as the coating and concrete restoration work to ensure a comprehensive and warrantable repair.

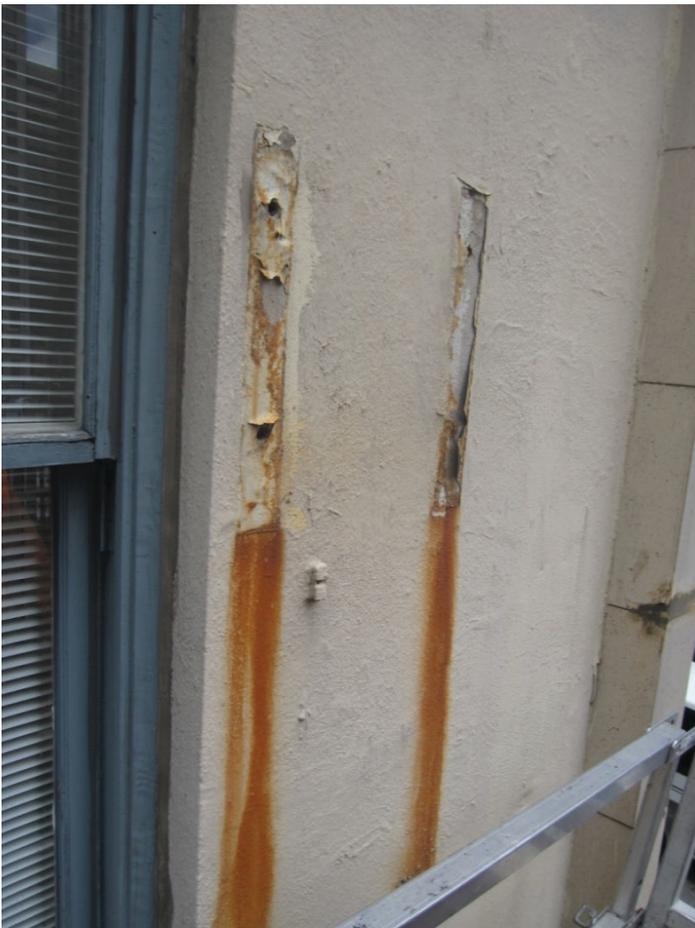
**PHOTO 3:** *Blistered, peeling, and stained paint.*

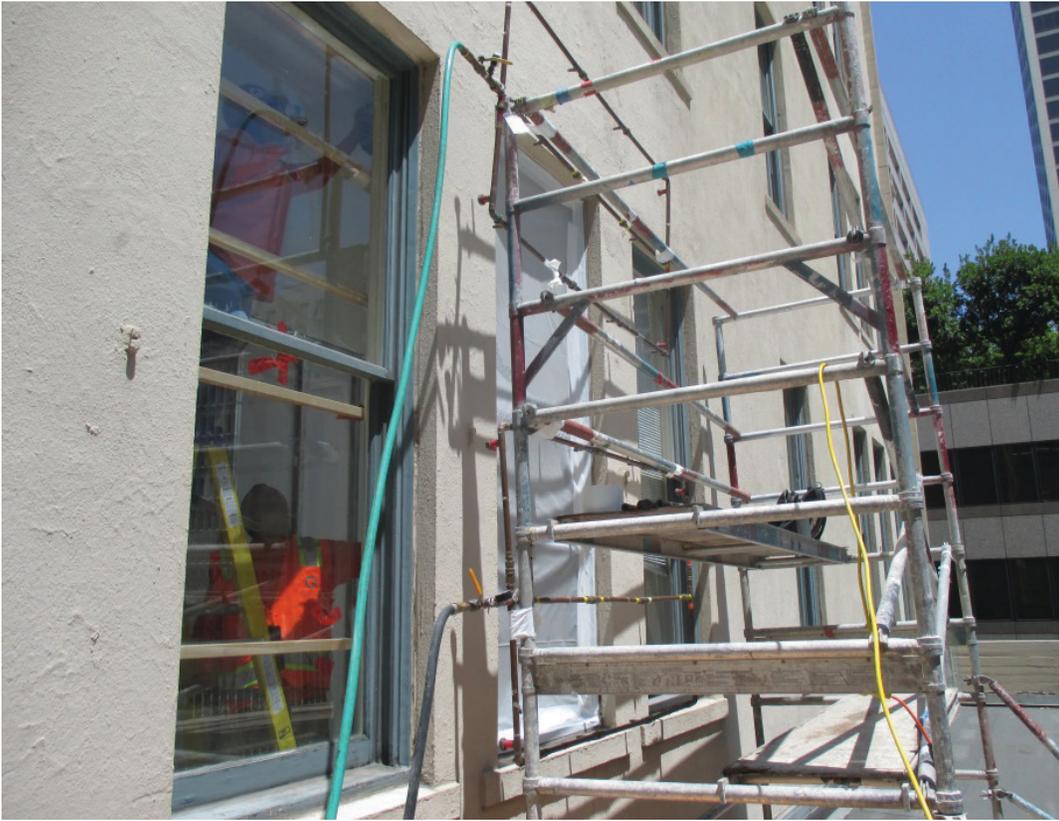
**PHOTO 4:** *Water testing with window isolated to test concrete wall.*

Differential pressure water testing per ASTM E 1105 revealed numerous leaks in the wood window frames, glazing joints, and perimeter sealant joints (Photo 4). Water also penetrated through the concrete walls at cracks and joints (Photo 5).

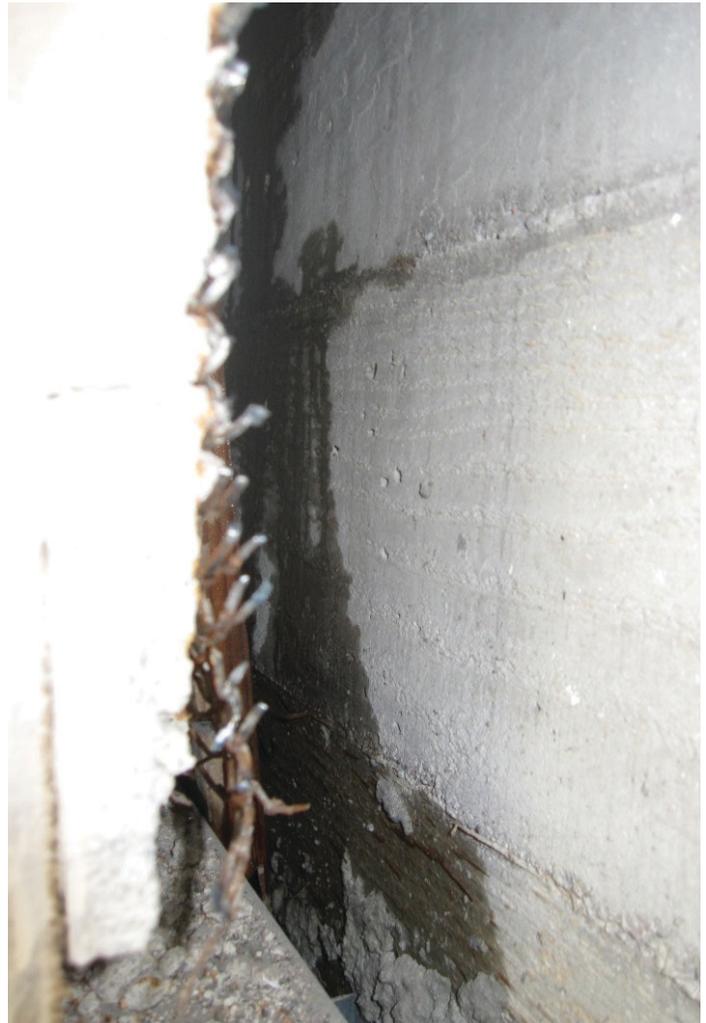
**PHOTO 5:** *Water infiltration appears on interior face of concrete wall.*

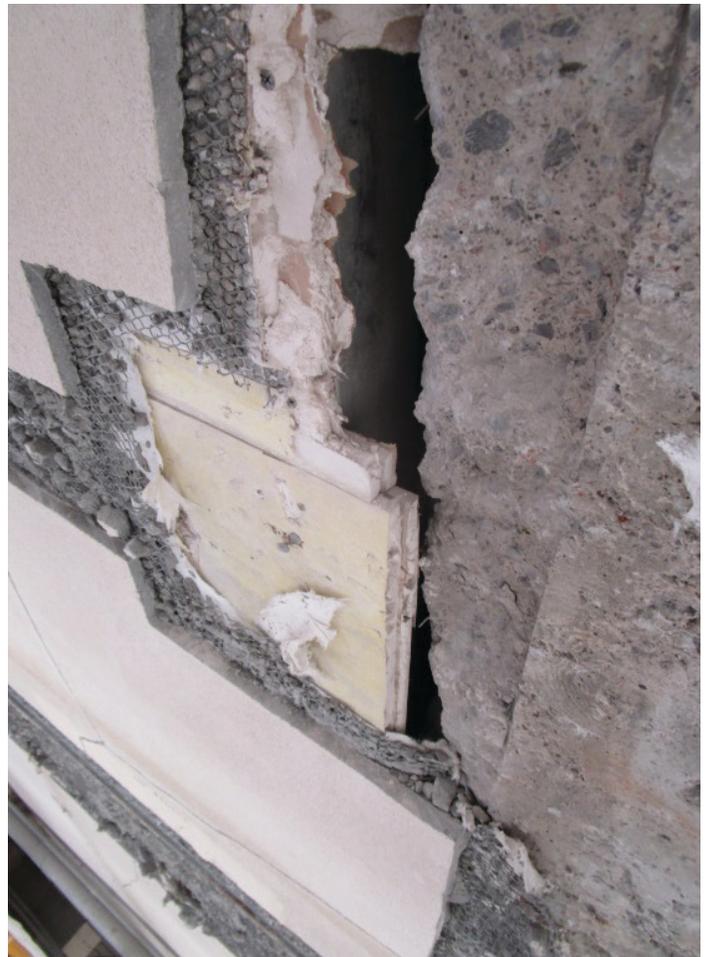
best adhesion test results, hand scraping provided a substrate that resulted in satisfactory adhesion. The existing paint was removed using hand scappers. Once the building was scaffolded, we conducted a close-up survey of the entire wall. To prepare for the concrete and parge coat repairs, the contractor and SGH developed independent surveys using sounding techniques to identify areas of delaminated or unsound material. During this phase, we found many localized areas of delaminated or unbacked material, including discontinuous backing at transitions from cement plaster to concrete parge (Photo 6). We found that the new shear walls were stopped short of the adjacent windows and the area between the concrete

**PHOTO 6:** *Discontinuous backing behind plaster around windows.*

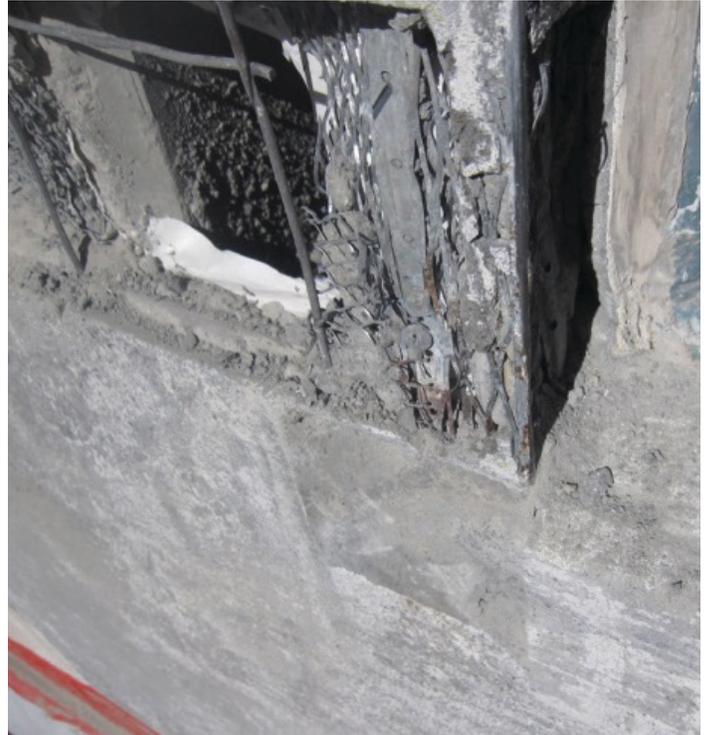
shear walls and windows was filled with lath and plaster over minimal light gage steel framing. There were no insulation, sheathing, air barrier, vapor barrier or flashings around the windows in these areas (Photo 7).

**PHOTO 7:** Gaps in wall substrate around windows covered simply with lath and plaster.

Because of the variations in the substrate and the reliance on the concrete to act as a barrier wall, we recommended considering a more robust coating system than the originally specified elastomeric coating. The contractor installed Dryvit TAFS II finish system, consisting of a base coat, reinforcing mesh, and finish coat over the substrate (Photo 8).

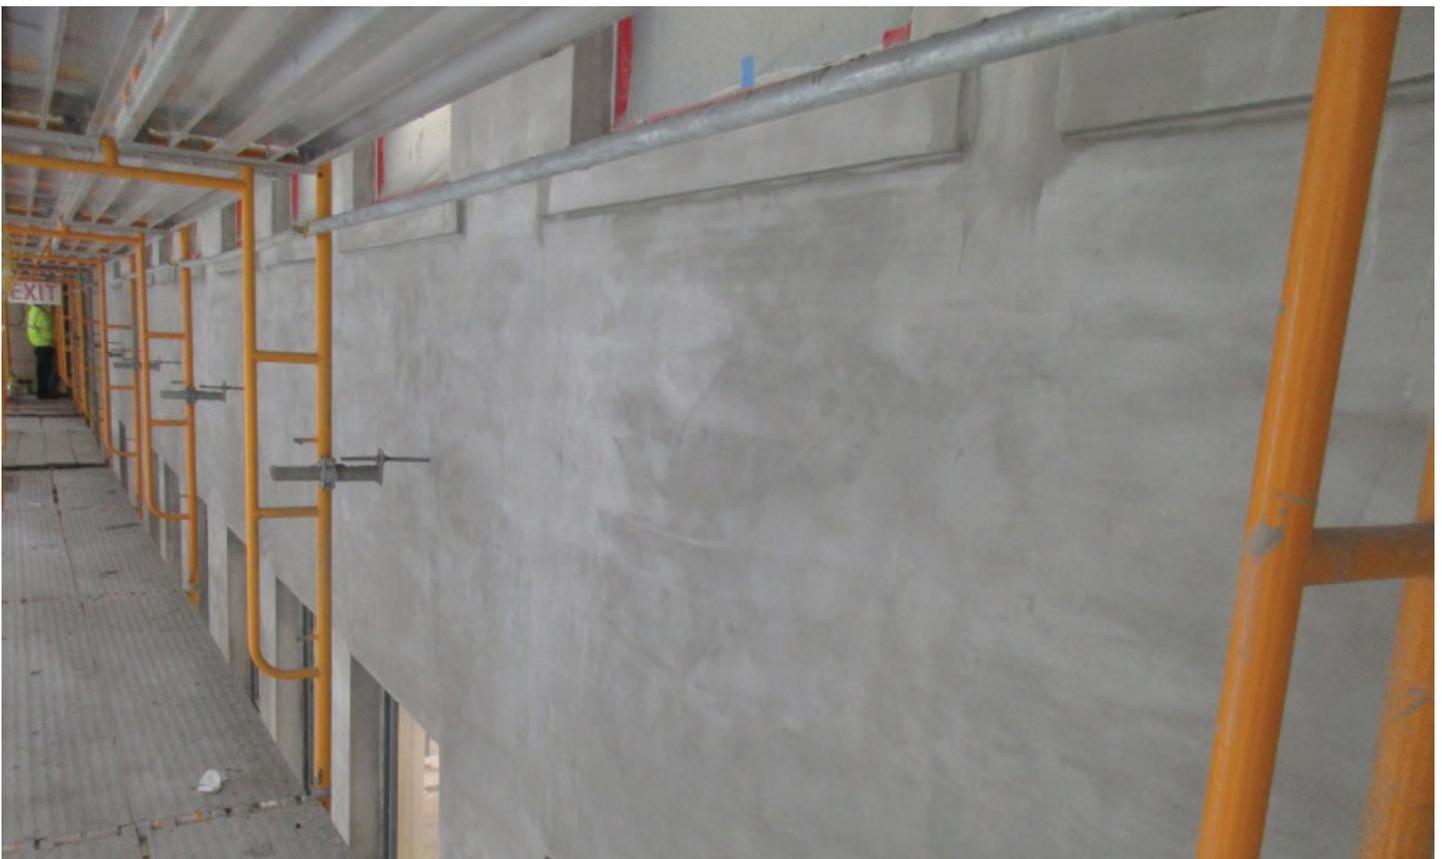
**PHOTO 8:** TAFS II fully reinforced base coat installed. Finish coat is not installed.

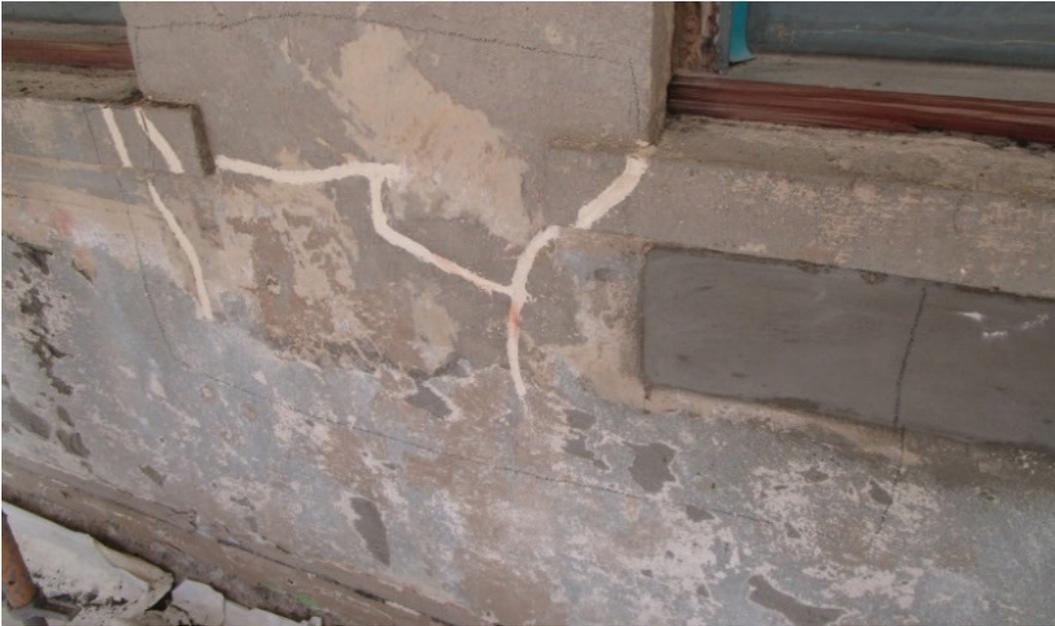
**PHOTO 9:** Existing concrete wall. Existing coatings are partially removed and localized spall and crack repairs are completed.

The contractor made conventional concrete spall repairs using SikaTop 123, a polymer modified cementitious patching mortar, #16 gauge stainless steel annealed tie wire and Stalgard coated Tapcon anchors (Photo 9). Where we had voids in the wall, we integrated 20 gauge galvanized sheet metal (GSM) backing to provide adequate backing. To repair light gauge framed rough openings, we reframed the jambs with GSM clips and exterior grade DensGlass sheathing (ref. Figure 1 below).

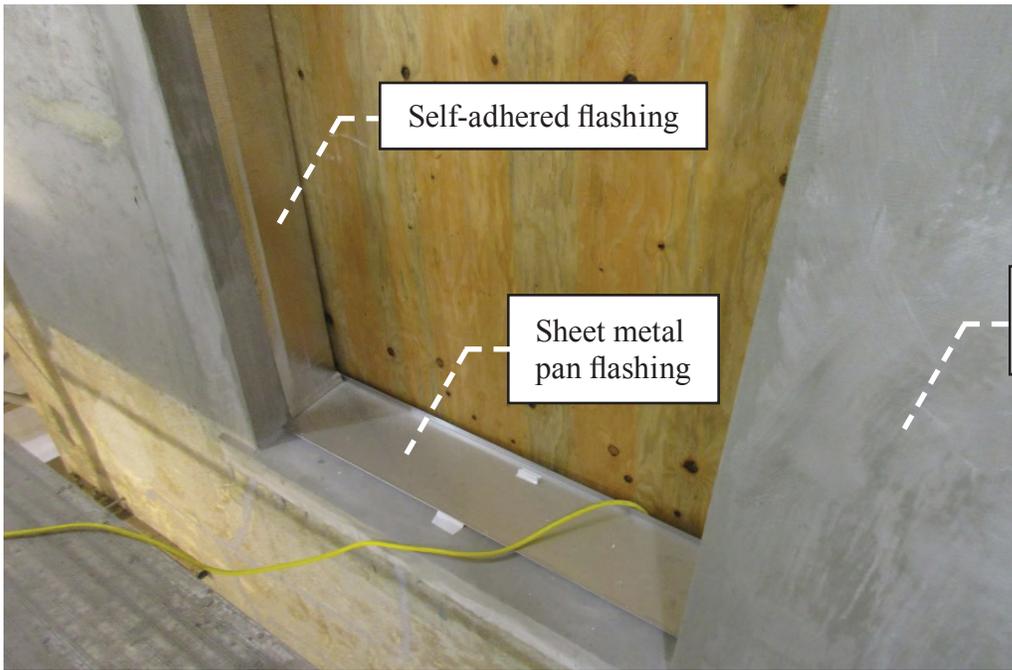
**PHOTO 10:** TAFS II, self-adhered flashing and stainless steel sill pans set in fully restored window rough opening.

The rough openings were stripped in with self-adhered flashing and finished with Sikaquick VOH, applied over stainless steel anchors and self-furring lath. We integrated the new windows with the coating by stripping in the window rough openings with the TAFS II base coat followed by stainless steel sill pans and self-adhered flashing prior to new window installation. (Photo 10). After window installation was complete, we installed perimeter sealant joints between the painted wood brick molds or sill pan and TAFS II base coat.

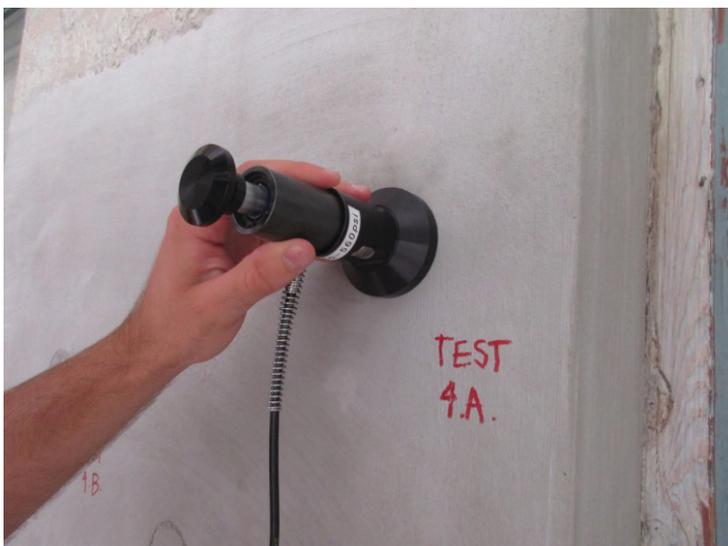
**PHOTO 11:** TAFS II adhesion test in progress.

We performed adhesion tests of the Sikagard 550W and TAFS II coating systems in general compliance with ASTM D7234-12: Standard Test Method for Pull-Off Adhesion Strength of Coatings on Concrete Using Portable Pull-off Adhesion Testers. We performed 50 adhesion tests on the Sikagard 550W coating and 24 adhesion tests on the TAFS II coating (Photo 11). We administered tests on an array of different substrates that varied in the amount of substrate preparation to determine the appropriate amount

of surface preparation required. Variations in the substrate included percentage of existing coating remaining, soundness of concrete, and primed or unprimed surface. The appropriate amount of surface preparation was selected by determining which surfaces achieve coating adhesion at a strength equal to or greater than the manufacturer's requirements. We performed sealant adhesion tests on each substrate and water tested two windows and the surrounding wall.
