**Hoover Pavilion opened its doors as Palo Alto Hospital in 1931 and was expanded in 1939. Stanford University co-owned and operated the hospital for a decade until 1968, when it purchased the facility, subsequently converting it to medical offices. Designed in the Art Deco style, the 85,000 gsf building features distinctive ziggurat massing, comprising three flat-roofed, four-story wings that radiate from a five-story central block and six-story tower.**

Page & Turnbull served as the preservation architect for the adaptive re-use of the Old Palo Alto Hospital, now known as Stanford Hoover Pavilion. The project goals set by the client, the Stanford University Medical Center, included: a historic restoration as part of the mitigation for a nearby expansion of the Stanford Hospital, and the creation of a state of the art Medical Office Building with new building systems.

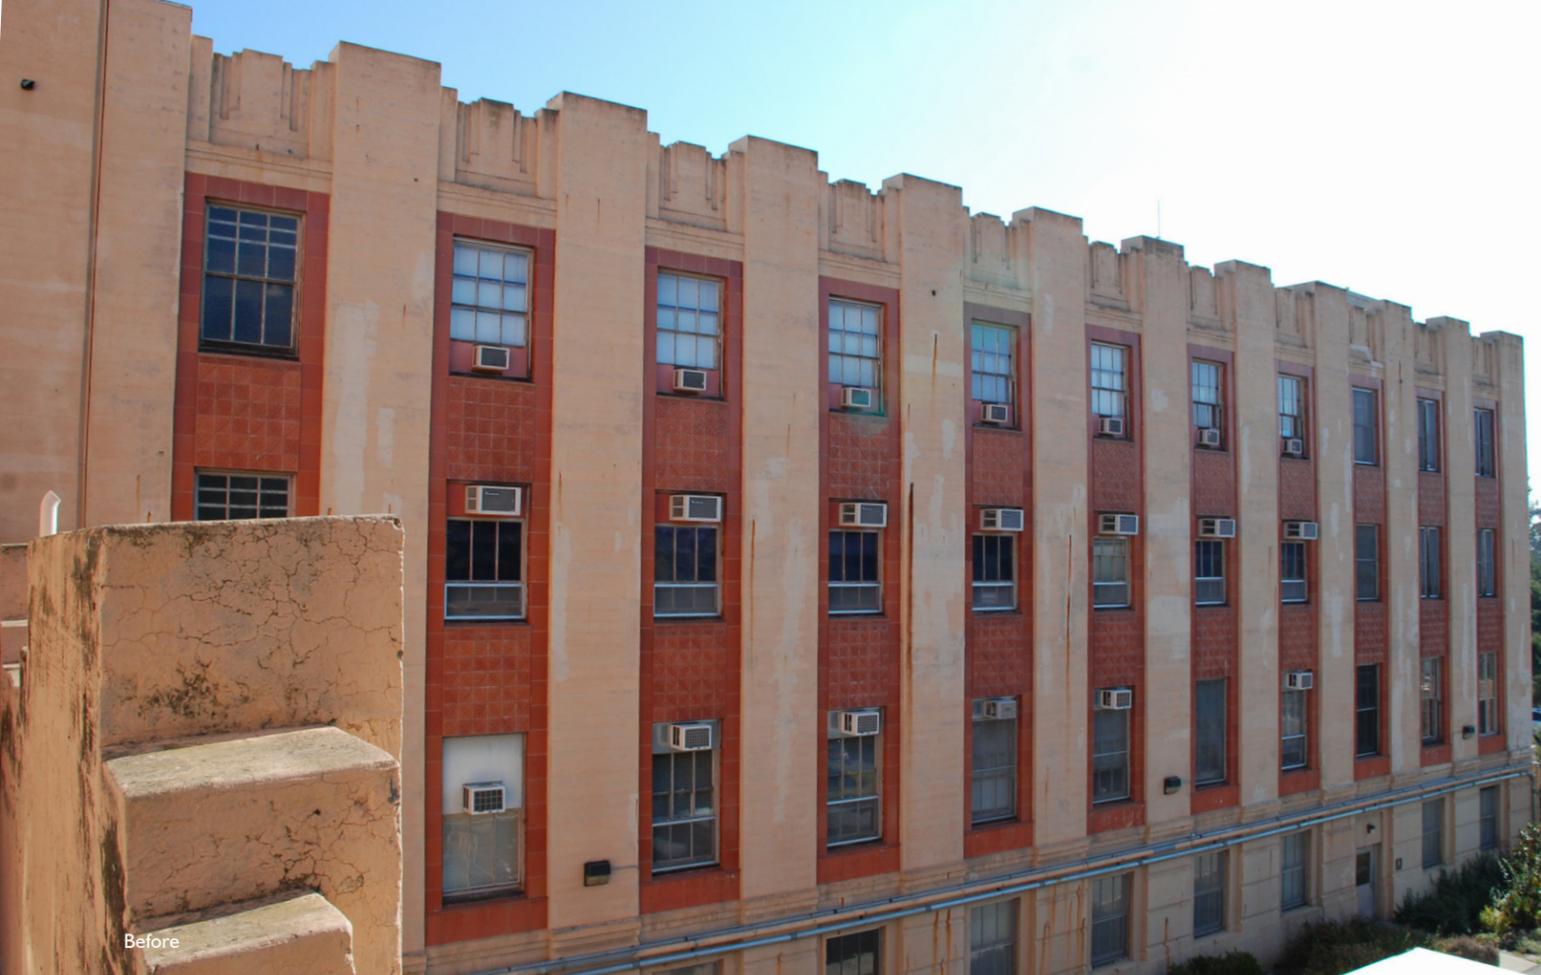
Before

## The Hoover Pavilion presented adverse concrete conditions in the form of pitting and staining across all facades of the building, but most prevalent at the 1939 addition wing.

During the project, issues with contaminated concrete aggregate used in the 1939 addition were discovered. Page & Turnbull provided the design team with a cost effective and aesthetically pleasing repair of the concrete.

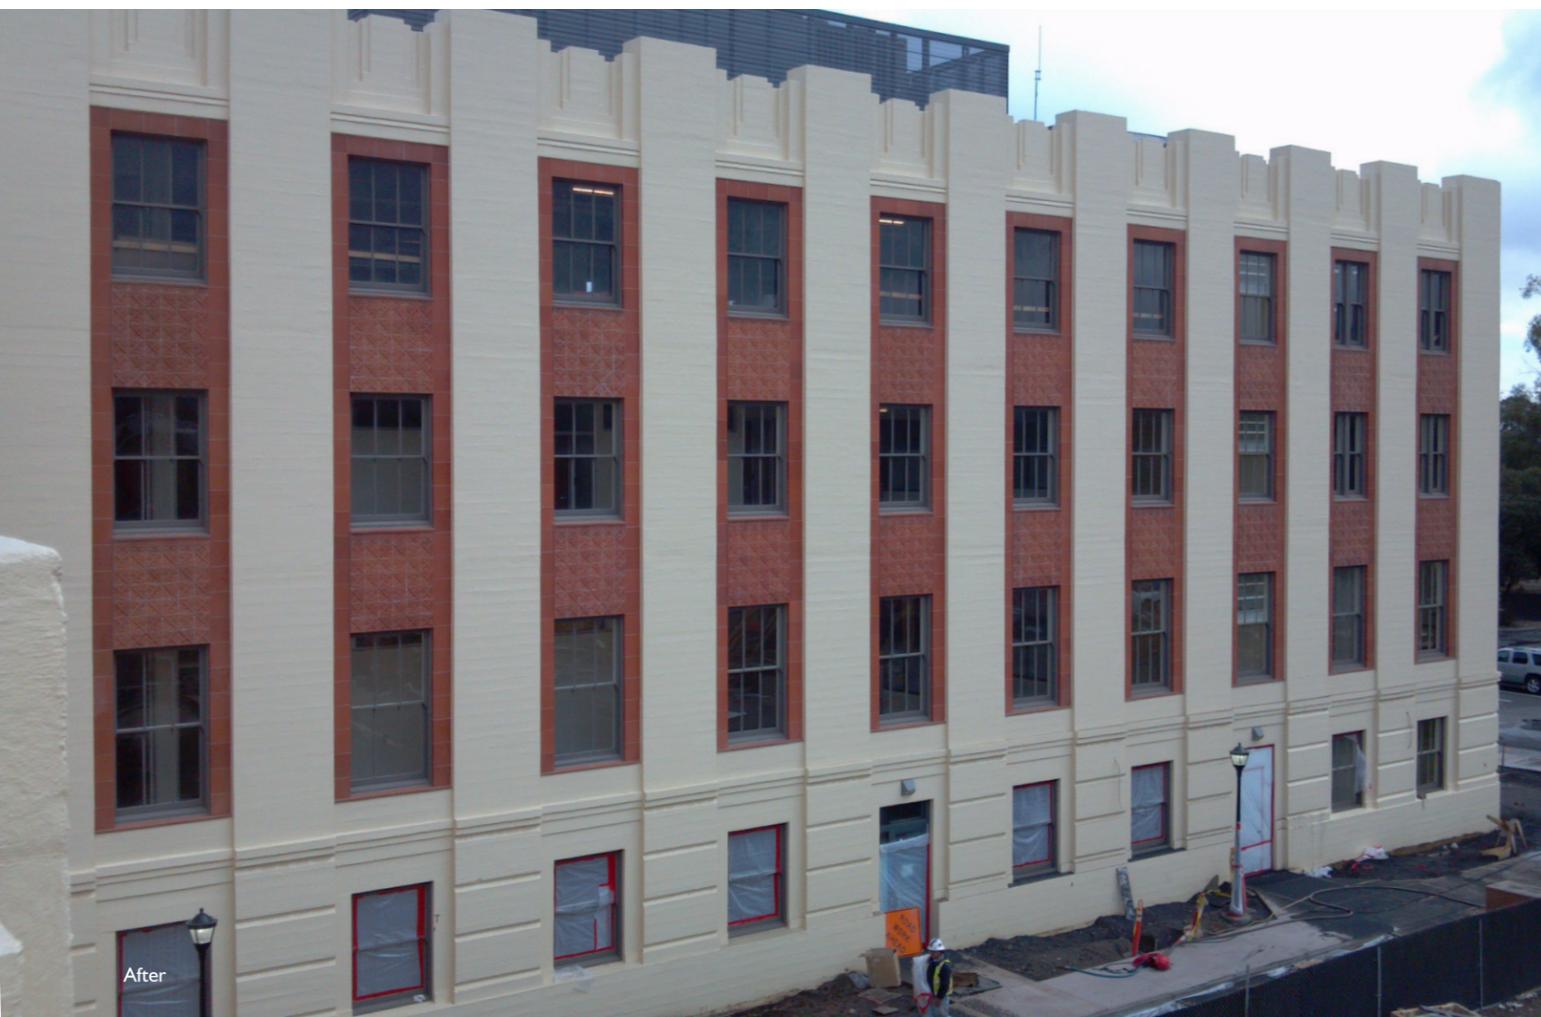
After

Page & Turnbull worked with skilled masons to fine-tune the patch repairs so they would match the board form texture of the concrete, a historical character defining feature. The final condition is a façade where even the trained eye cannot perceive the concrete repairs.

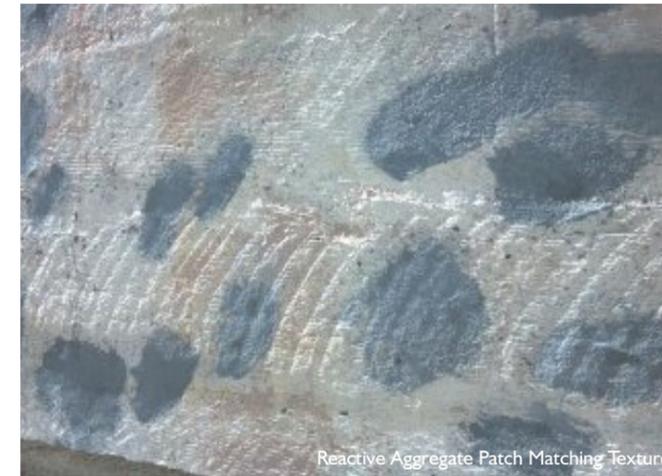
Reactive Aggregate Patch Matching Texture

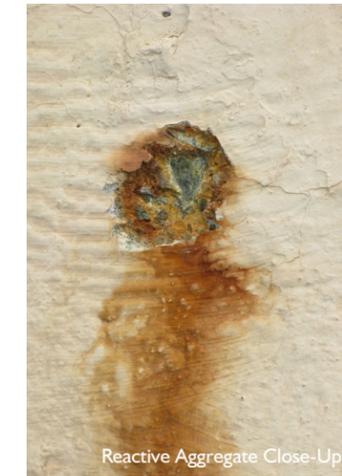
Reactive Aggregate Close-Up

Through laboratory analysis, Page & Turnbull determined that the original concrete mix included iron pyrite within the aggregate. When subjected to moisture this reactive aggregate would oxidize and expand, resulting in pop-outs and staining. This condition is perhaps nothing new to the experienced concrete repair expert, as it has been observed at slabs and sidewalks on past projects and well documented. However, the extent of this condition present on a building façade was neither previously encountered in our 50-year office history, nor could be found in scholarly documentation. Over 400 pop-outs were identified through survey prior to construction and additional reactive aggregates were identified during the repair process. These quantities do not include the extensive previous repairs conducted by the University prior to our intervention.

The testing determined that locating potentially reactive aggregate prior to the oxidization process was not possible. Therefore, locating the pyrite could only take place once the damage had already been done. As a result the repair approach focused on preventative measures by limiting the wet/dry cycles (exposure to water) to arrest the process of oxidization. The project accomplished this by careful preparation and repair of the concrete pop-outs and an exhaustive mock-up process to select the appropriate coating as well as removal of the existing paint systems.

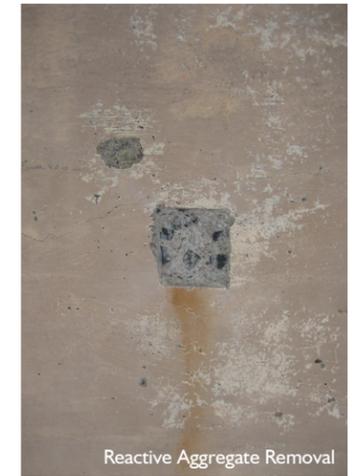
Reactive Aggregate Removal
