**Alcatraz Quartermaster Building Seismic Upgrade  
ICRI Northern California Chapter  
2017 Concrete Repair Awards Submission**

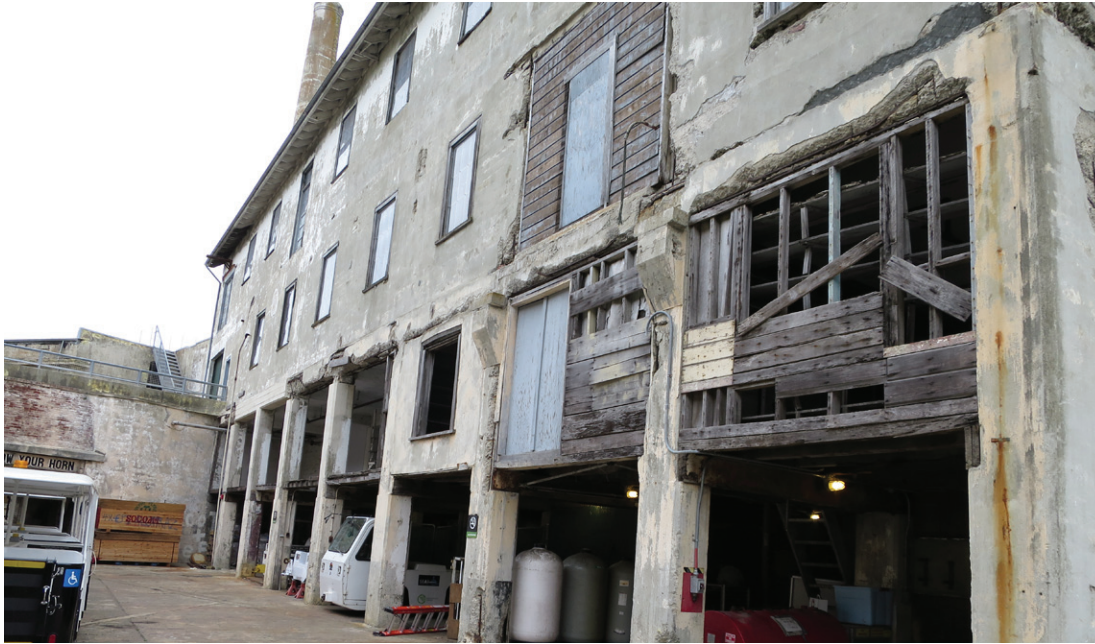
including large spalls and exposed corroded reinforcing steel at the walls, beams, columns, and floor slabs. Deterioration was most severe at the exterior walls, but also visible throughout the interior. In many cases, rebar was observed very close to the surface at cracks and spalls.

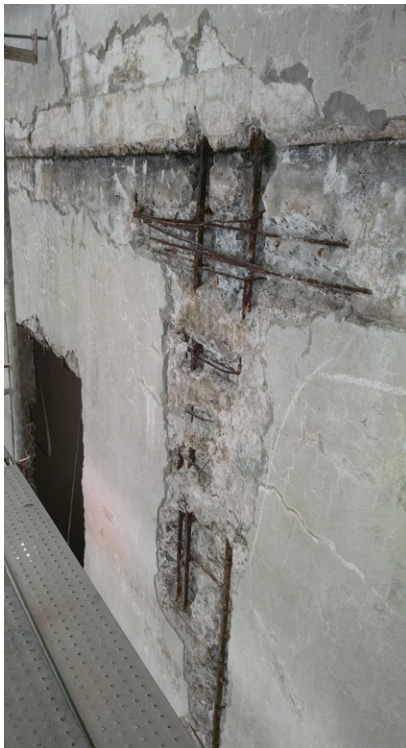
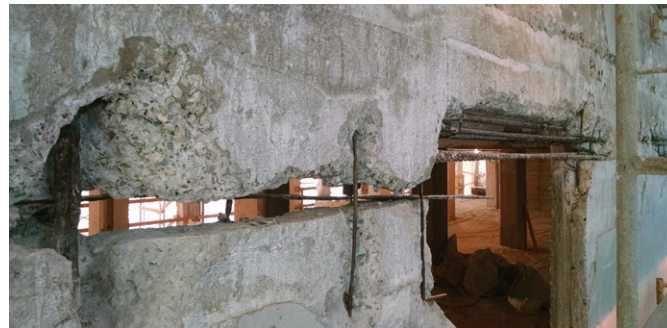
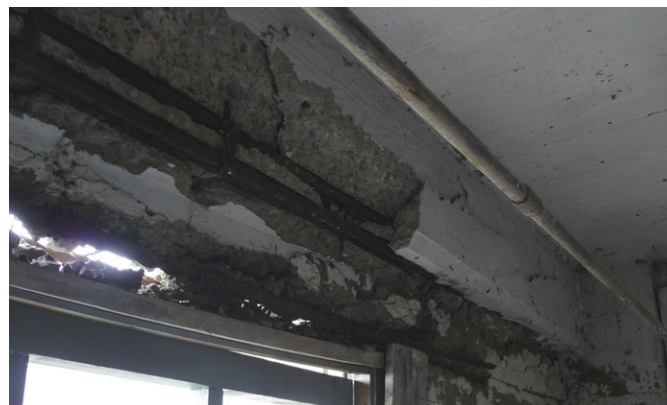
Concrete repair systems were evaluated based on their compatibility with the historic concrete and its finish system. Existing conditions were typically either severe or good – there was very little small-scale or shallow repair. For example, there were large areas of severely deteriorated concrete, with large surface spalls, crumbling concrete substrate, and heavily corroded exposed rebar, but just a few feet down the wall the concrete would be completely intact and undamaged. For these reasons, a comprehensive repair system that could be used for all levels of repair and coatings was sought. The repair system also needed to be able to blend with the historic concrete finishes, and cost was a concern due to the large volume of repairs needed.

A Sika repair system, including a large-repair concrete mix product, small-scale repair mortar, repair mortar for the parge coat, bonding agents, and a series of protective finish coatings, was used to create a comprehensive repair assembly.

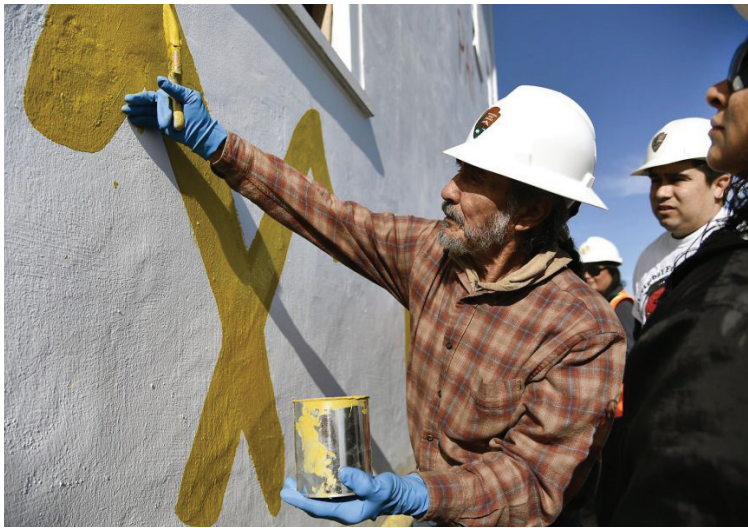
*Restoring the Political Statement after concrete repair at the Quartermaster Warehouse, 2016.*

The decision was unanimous, to restore the painting after repair of the exterior wall surface. The Political Statement was recorded with a full size tracing of the lettering created with the support of a decorative painter. After repair of the wall surface, the tracing was transferred to the wall surface by the Contractor for the rehabilitation project. In March 2016, Native Americans from various tribes gathered to complete the painting. The political statement is now more visible and rests on a stable, repaired concrete substrate.
