## Restoration of 100+ Years Old Public Building

Project: Hall of Records, Bakersfield, CA

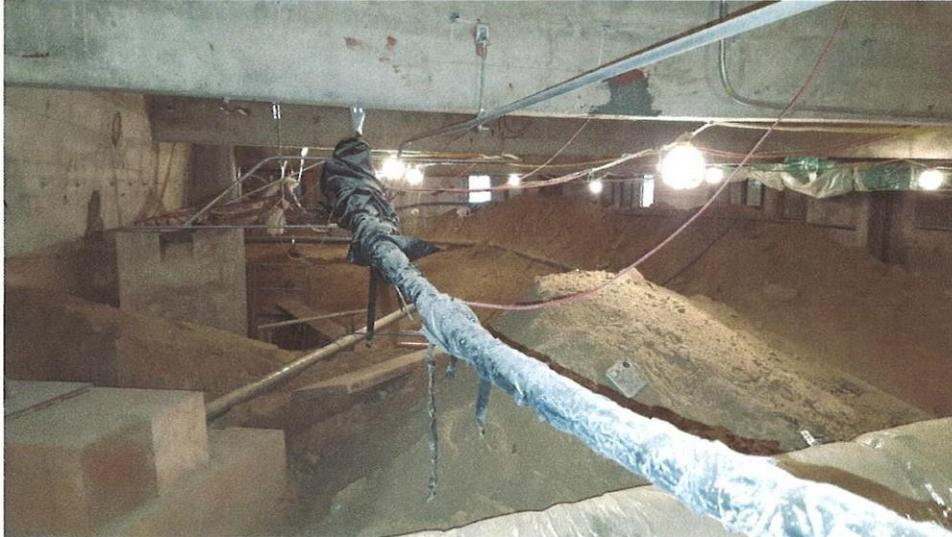
Signs of concrete deterioration in the approximately 9,000 ft<sup>2</sup> unfinished crawl space were noted during the 1988 retrofit, and in 2013 investigations showed that several columns, pilasters, and beams showed signs of severe spalling, delamination, corrosion, and cracking. A more detailed investigation was requested to determine any additional defects in the crawl space concrete and the cause of the reinforcement corrosion.
